JOINT HIGHWAY RESEARCH PROJECT

JHRP-74-16

ANALYSIS OF DRIVER REACTION
TO WARNING DEVICES AT A
HIGH-ACCIDENT RURAL GRADE
CROSSING

Final Report

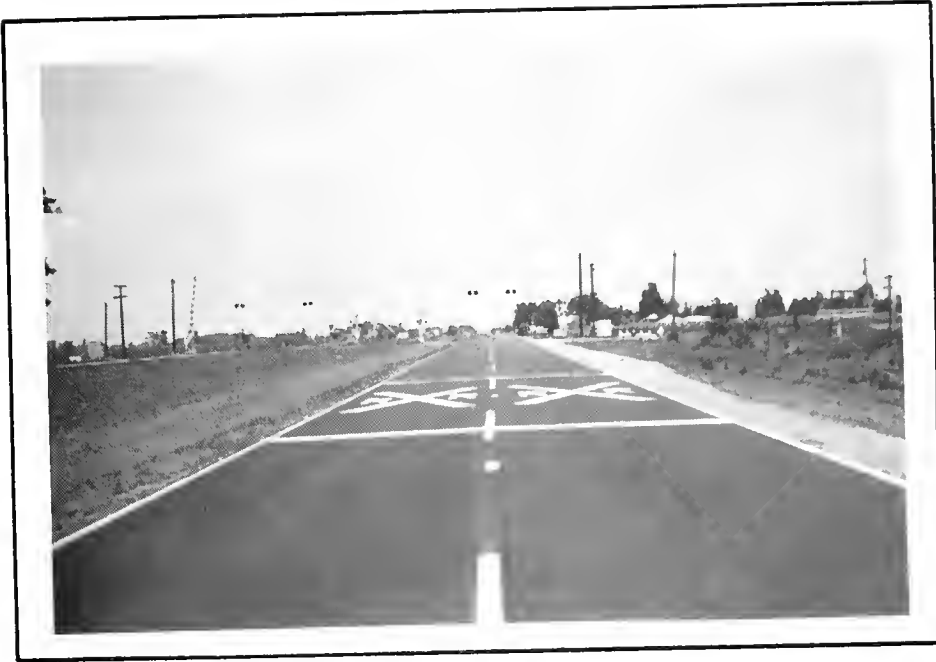
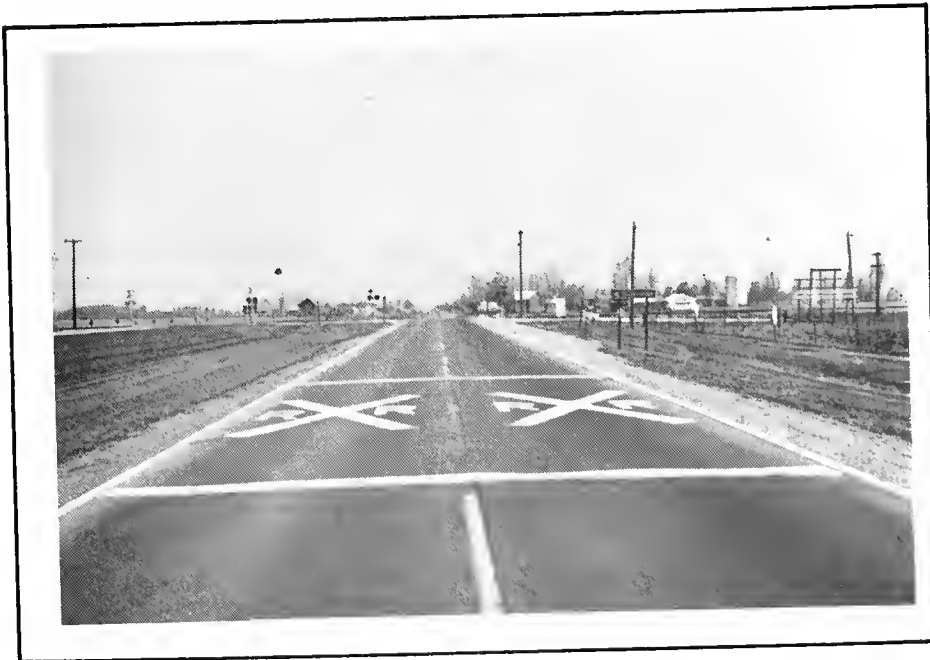
FIGURE 14. THE GOLDSMITH GRADE CROSSING AS VIEWED FROM THE NORTHBOUND LANES OF U. S. 31 BEFORE AND AFTER PROTECTION IMPROVEMENT

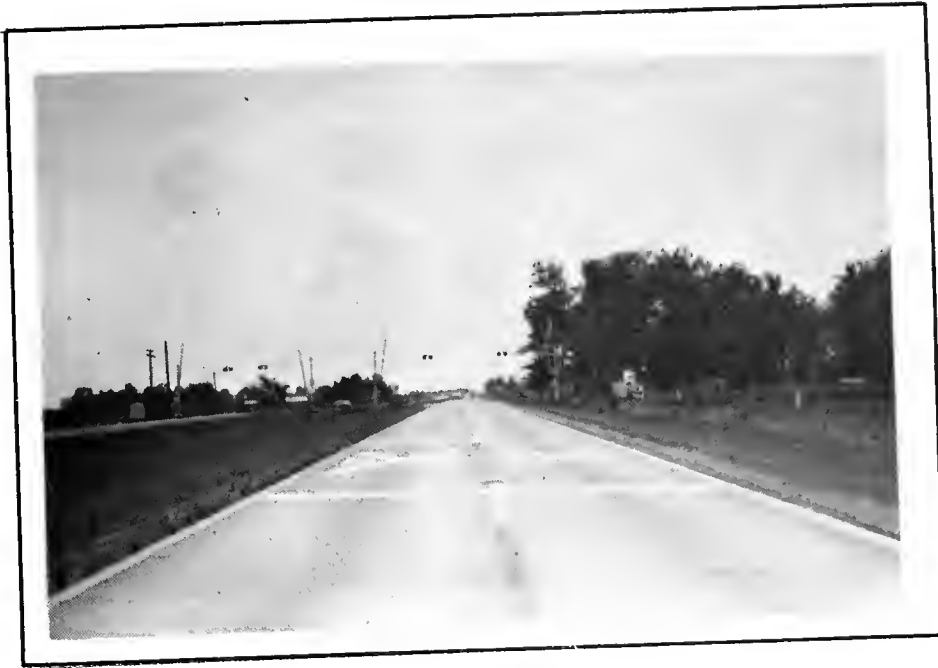
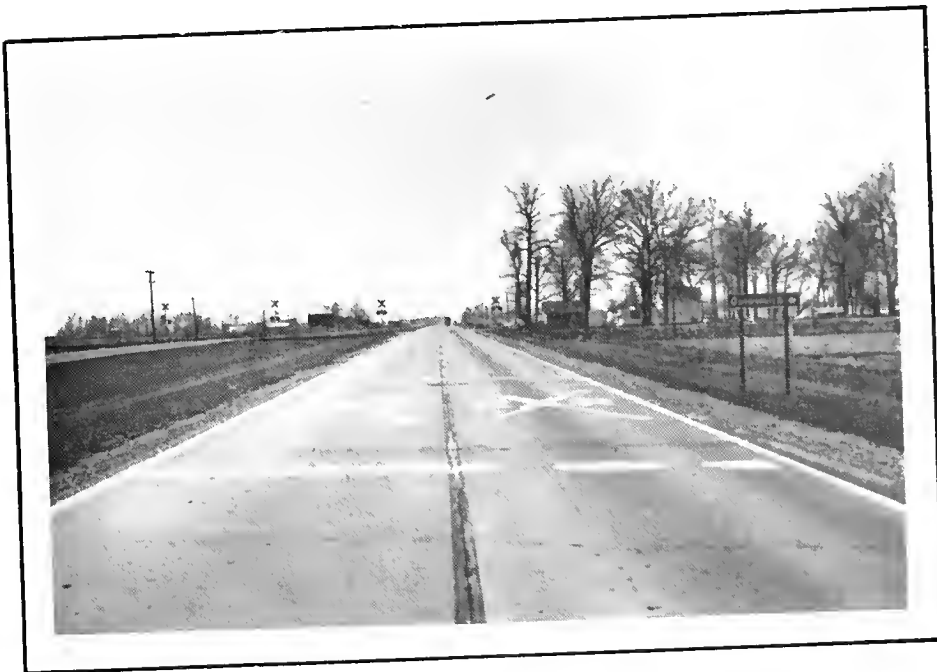
FIGURE 15. THE GOLDSMITH GRADE CROSSING AS VIEWED FROM THE SOUTHBOUND LANES OF U. S. 31 BEFORE AND AFTER PROTECTION IMPROVEMENT

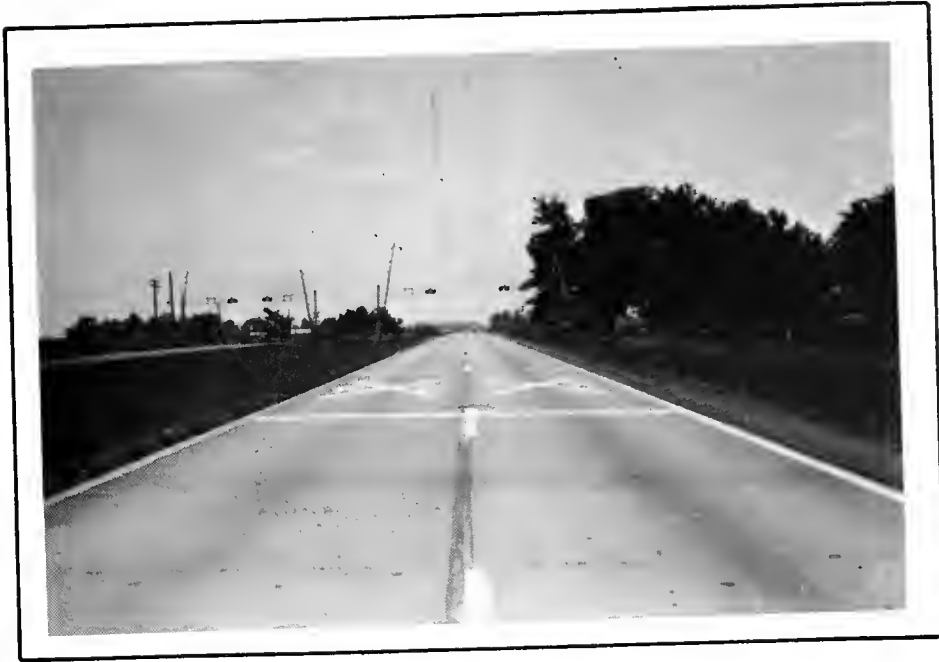
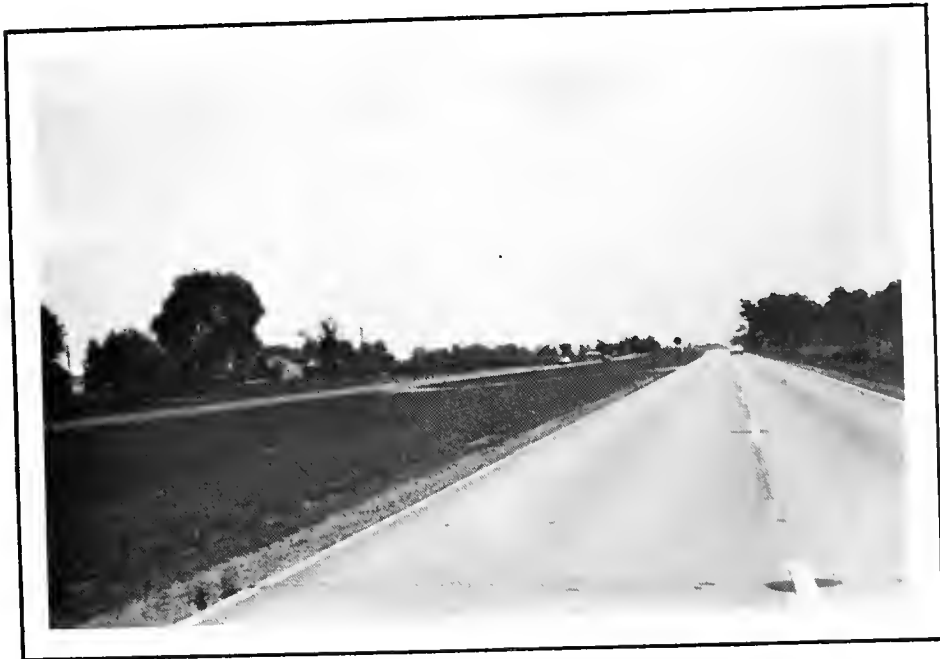
FIGURE 16. TWO VIEWS OF THE GOLDSMITH GRADE CROSSING AS VIEWED FROM THE SOUTHBOUND LANES OF U. S. 31 EMPHASIZING BACKGROUND OF TREES

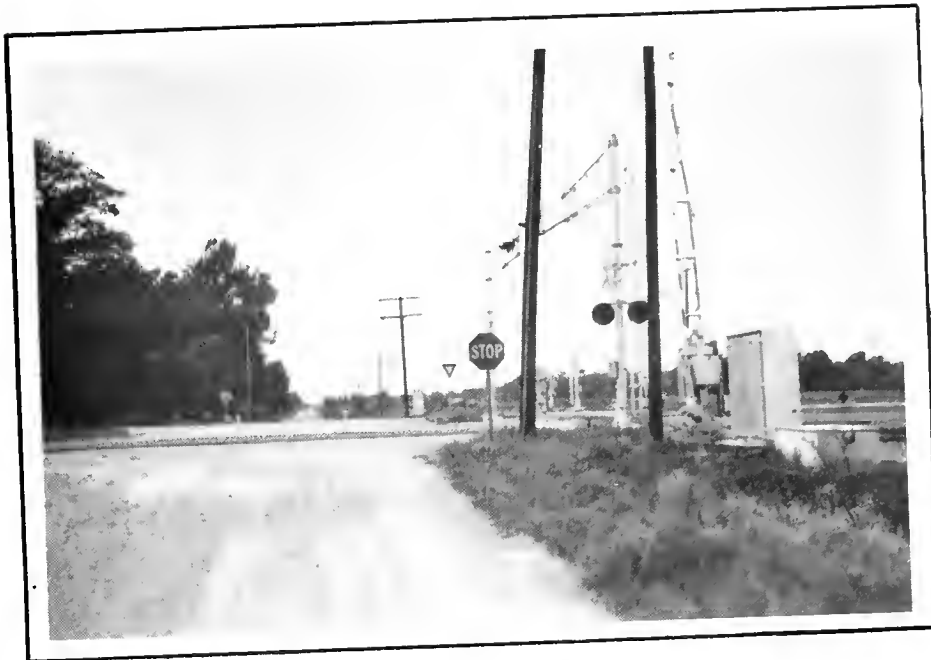
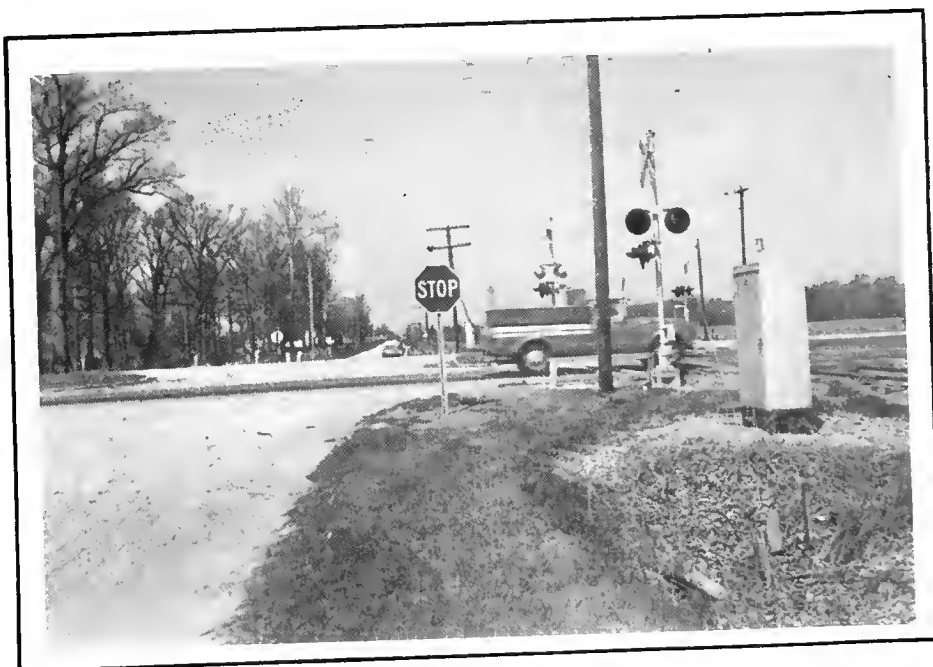
FIGURE 17. THE GOLDSMITH GRADE CROSSING AS VIEWED FROM 100S LOOKING WEST PARALLEL TO TRACKS

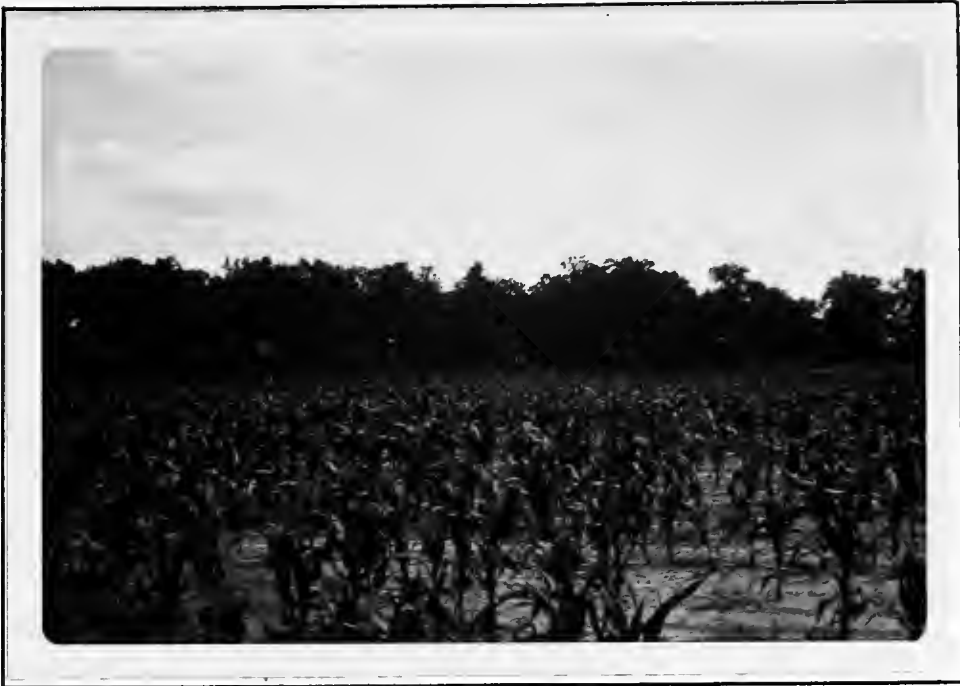
FIGURE 32. FRONT OF TRAIN AGAINST DARK BACKGROUND IMMEDIATELY WEST OF THE GOLDSMITH GRADE CROSSING

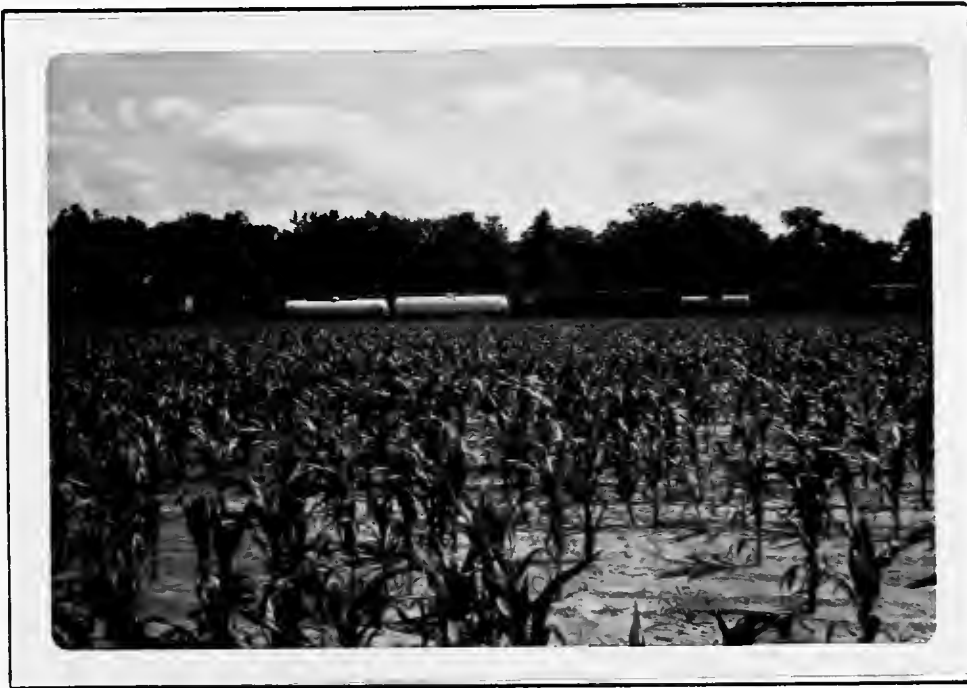
FIGURE 33. MID-SECTION OF SAME TRAIN SHOWING CONTRAST OF WHITE TANK CAR AGAINST SAME BACKGROUND

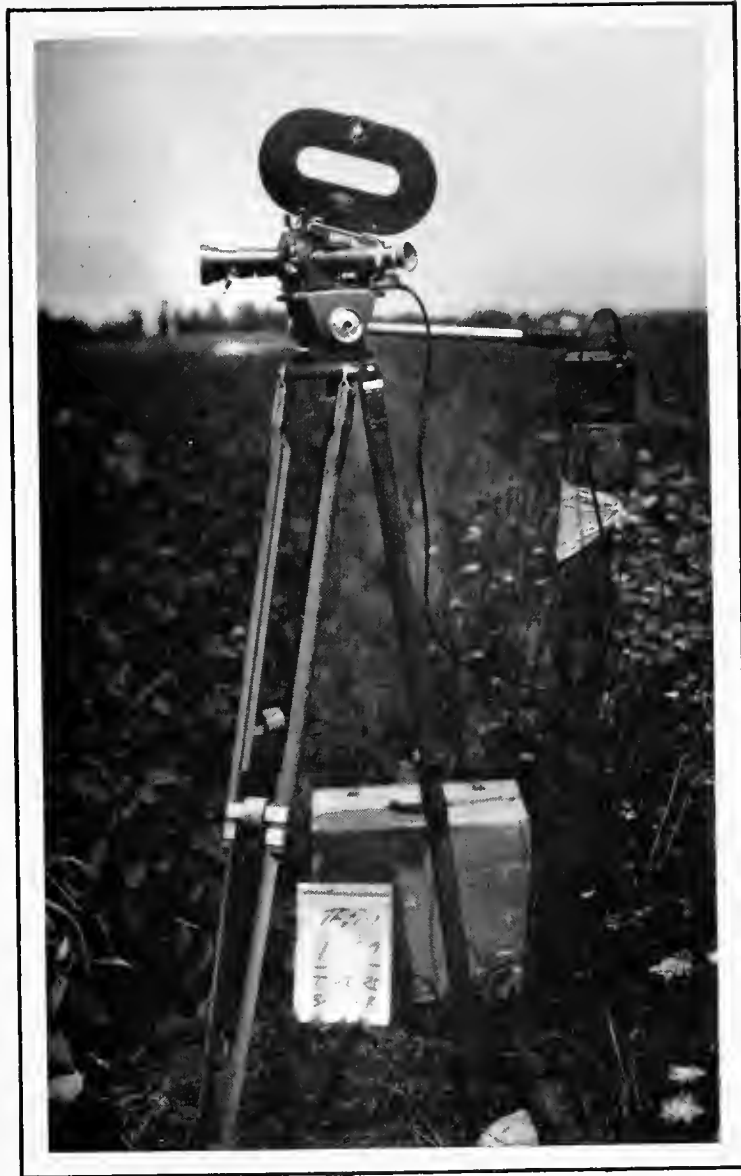
FIGURE 35. CAMERA SET-UP, READY FOR DATA COLLECTION UNDER NORMAL CONDITIONS

Since it was necessary on this project to use a 120 mm telephoto lens and "pan" with the camera to follow a car through the sequence of traps, the distance from the road could have been increased to 1000 ft. or more with no additional disadvantage. Taking advantage of this greater distance may allow a more convenient set up location, e.g., a field access road may be available. With larger markers, one could take advantage of even greater camera range. However, one must consider the possibility that large markers could possibly be too conspicuous and, therefore, have an effect on driver performance that could bias the results.

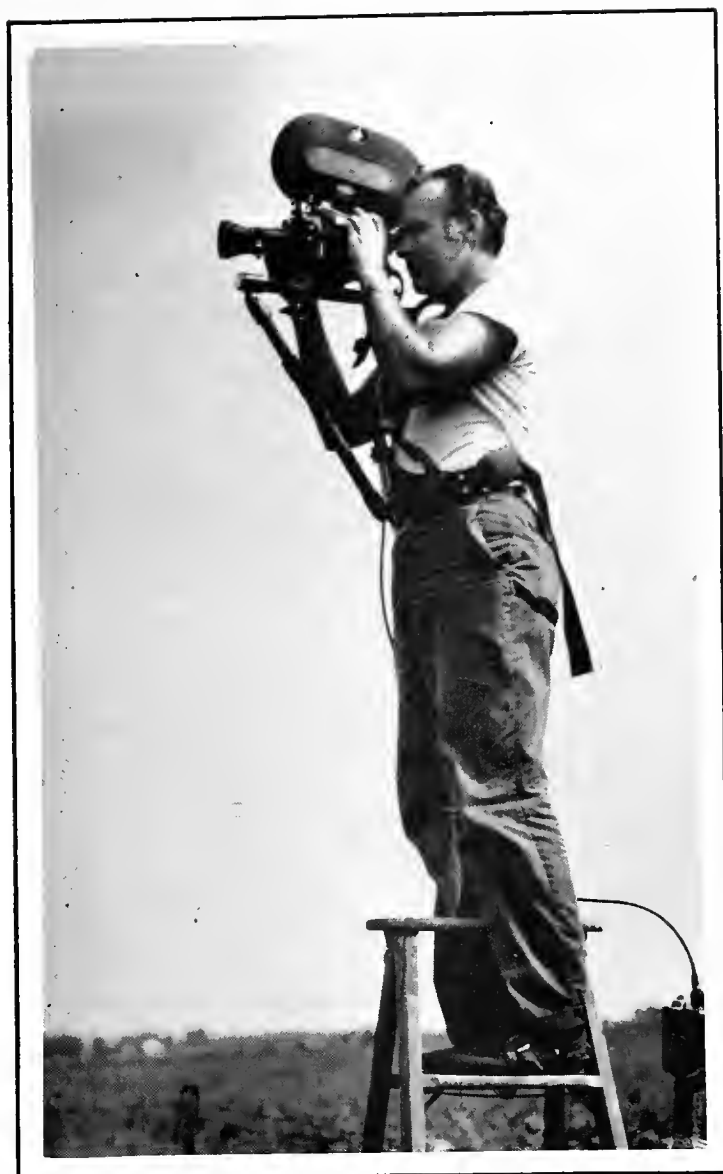
FIGURE 36. CAMERA SET-UP USED TO SIGHT OVER BEANS
THAT OBSCURED THE LINE-OF-SIGHT LATE
IN THE SUMMER
